# PREMATURE FAILURE OF MODERN GENERATORS

Clyde V. Maughan, President  
Maughan Generator Consultants  
Schenectady, NY, USA

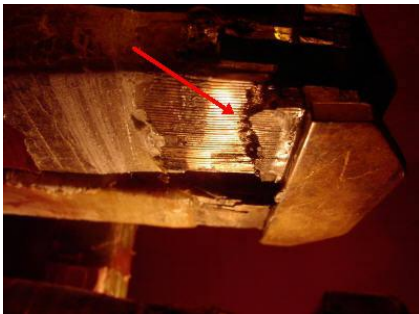
Endwinding vibration has been an ongoing problem on large generators. Problems have accelerated as engineers have designed for higher vibration driving forces and simplified support systems. Eliminating series blocking on an endwinding resulted in the broken bar shown in Photo 1.

Photo 1. Broken series connection.

Protection against these type failures is probably best obtained by being sure that bump test is performed on new windings and reworked windings. Resonant values should be outside the 115-140 Hz range (for 60 Hz generators).

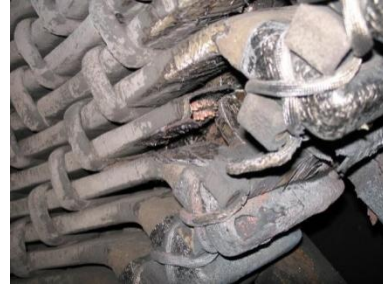
Local endwinding resonance resulted in the failure shown in Photo 2.

Photo 2. Several inches of copper burned away on a stator bar.

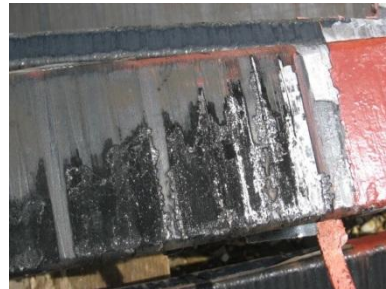
Large indirectly cooled generators tend to be made with many stator slots and tall, narrow bars. This design approach maximizes the area for transferring heat through the groundwall insulation. But it also allows the tall, narrow bar to vibrate sideways in the slot, probably driven by the core vibration. This vibration results in vibration sparking, a fast acting destructive phenomenon. Photos 3 & 4.

Photo 3. Side of a bar deeply damaged by vibration sparking.

It has been supposed by designers that side filler would not allow side vibration, but since incremental thickness packing cannot fill the space fully, vibration can occur. Corrective action probably requires rewind to remove

the fatally degraded bars and allow installation of side pressure springs.

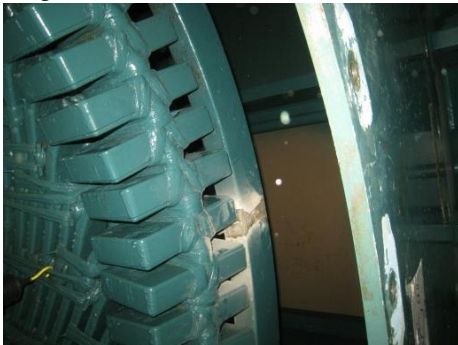
These dry ties have not performed well and have led to numerous problems. Photos 5 & 6.

Photo 5. Dust generation from failed dry tie.

A few years of operation may result in heavy wear at several locations, leaving significant exposure to phase-to-phase fault. The resulting arc will be massive and may severely damage the generator.

Scope of repair depends upon the amount of damage. If the integrity of the insulation is undamaged, simply replacing the dry ties with wet ties may be all that is required. But at the other extreme, corrective action has apparently required generator replacement.

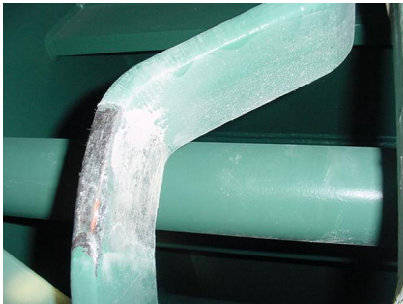
Photo 6. Bare copper exposed from wear of a dry tie.

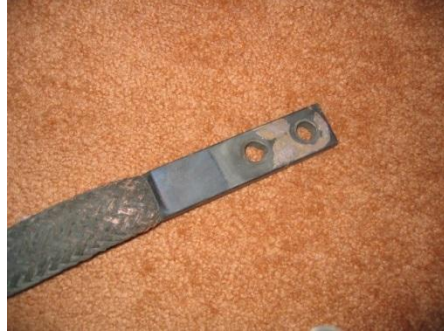
Photo 7. Failing flexible lead, high voltage bushing to isophase bus.

Prevention of bolted joint problems involves being certain that: 1) connecting surfaces are properly plated, 2) the surfaces are clean, 3) the selected torque values are correct, and 4) the nut/bolt torque is not resulting from galling or other friction conditions.

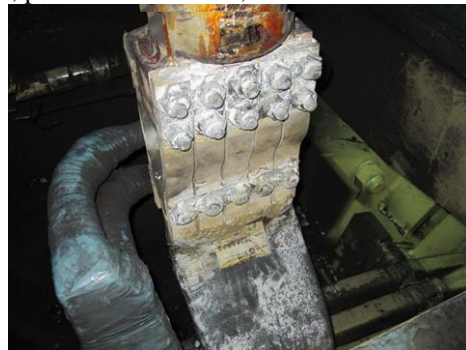
A joint similar to Photo 8 was made up with stainless steel bolts. Stainless steel has a propensity to gall, and in this case the nut-to-bolt galling absorbed the torque of the wrench and left some bolts loose, but with apparent proper torque. The result was joint failure, massive arcing, thorough contamination – and a stator and field rewind, plus weeks of frame, cooler and core cleaning.

Photo 8. Bolted high current connection.

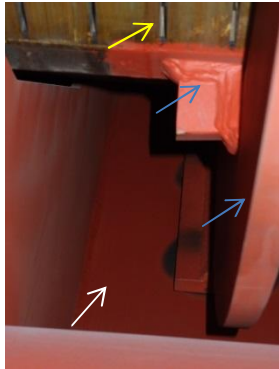
Photo 9. Core-to-frame attachment arrangement.

This configuration eliminates the cost of the isolation components, but leaves the generator vulnerable to noise levels approaching 116 dB, and the prospects of frame and foundation cracking.

Operation may be acceptable if the noise levels can be tolerated and frame and/or foundation cracking is not occurring. Otherwise, this condition may not be correctable without stator (or generator) replacement.

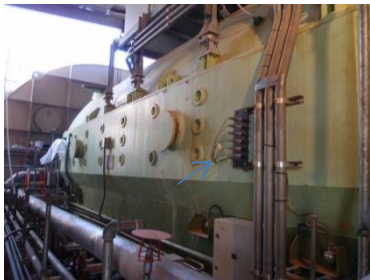
Photo 10. Outer frame.

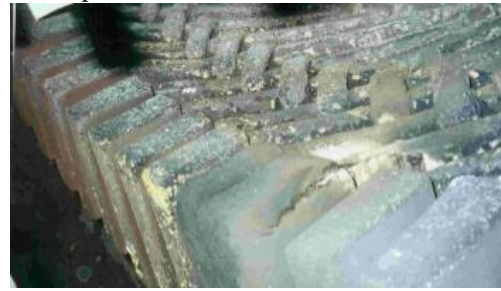
These connections are difficult to insulate with mica tapes. Thus for many years, there has been widespread use of a much faster and lower cost insulating method, i.e., the use of insulation consisting of non-conducting box filled with non-mica potting compound. This is perfectly adequate at the low voltage difference of the series connections. But if air gap clearances are less than about 3/8” at phase-to-phase locations, partial

Photo 11. Failed phase connection.

Photo 12. Phase-to-phase copper burning due to non-mica connection insulation failure.

Designers now typically use potting compound on the series connections, but tape the phase connections with mica tapes. Or alternatively, assure adequate physical spacing.

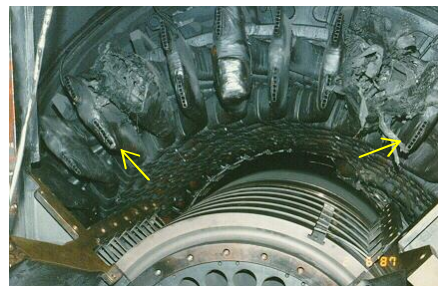
On direct-gas-cooled stator windings it is impossible to fully insulate the connections – access for gas flow must be permitted. Numerous massive winding ring-of-fire failures have resulted on machines where the insulating surfaces and air gaps have become heavily contaminated, for example due to an arc resulting from a broken bar or connection. Photo 13.

Photo 13. Ring-of-fire failure of a stator endwinding. Arrows identify typical exposed bare conductor locations.

On stators manufactured with bared conductor, there does not appear to be mitigating capabilities other than attempting to assure that no gross contamination occurs.

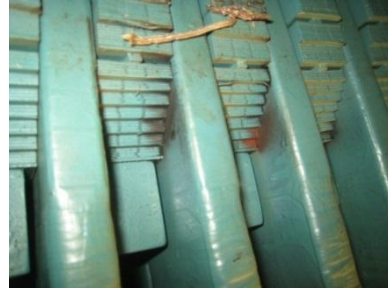
High design uprate of generators requires that the core have a much greater step-down of the iron at the ends of the core. Because the top of the top bar now is above the core iron, there is high air-gap flux cutting the copper at the top of the top bar and there will be a significant electromagnetic side-force driving side vibration on the top bar. This seems to be resulting in vibration sparking and other concerns on the winding. Photo 14.

Photo 14. Dust generation probably resulting from vibration due to side forces on top bar.

This is a relatively new phenomenon, and assistance of the OEM should be obtained for assessing the possible scope of concern and possible corrective options.

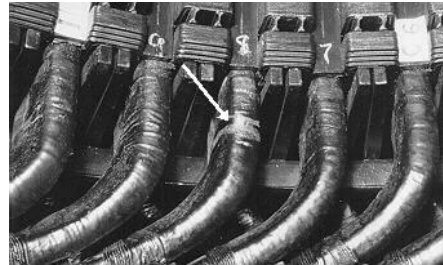
This was a highly destructive deterioration mechanism on asphalt windings on large (>40 MW) pre-1960 generators. Photo 15.

Photo 15. Typical tape separation (“girth crack”) on a pre-1960 stator bar.

5. Asphalt stator winding incorrectly diagnosed as having destructive migration of the groundwall. Photo 15. An inexperienced OEM engineer, and an inexperienced independent consultant, each recommended immediate stator rewind to avoid “catastrophic service failure”. Their recommendations were vacated by a more experienced engineer, and this stator winding continues to operate safely many years afterward.

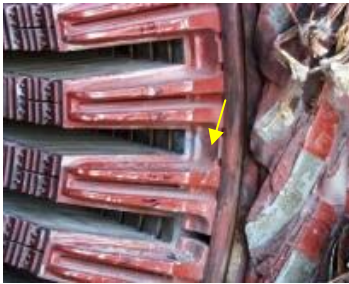
4. Core discoloration at the location of stator winding failure judged to be insignificant after inspection and deficient EICid test. This 80 MW stator was then rewound without correcting the core-iron condition. The new replacement winding failed in service shortly after return to service. Photos 18 & 19.

Photo 18. Minor iron discoloration judged to be insignificant.

Photo 19. Same core location after a few hours of excitation.
